## **Refurbishing Roof Systems and Roof Terraces on a Major Residential Building Complex**

**Tommy Bunch-Nielsen, Danish Roofing Advisory Board  
Erik Brandt, Danish Building Research Institute  
Denmark**

A major residential building complex with 1,725 apartments where two renovations of the roof systems and terraces have taken place has been surveyed during a period of more than 35 years. The building includes a large number of roof designs in the form of roof terraces, vegetative roof systems and ballasted roof systems.

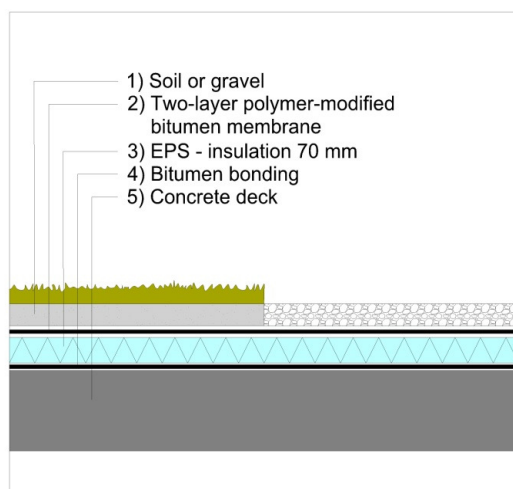
The original roof systems were a combination of vegetative roof systems and ballasted roof systems as shown in Figure 2.

Figure 2: Original vegetative and ballasted roof systems

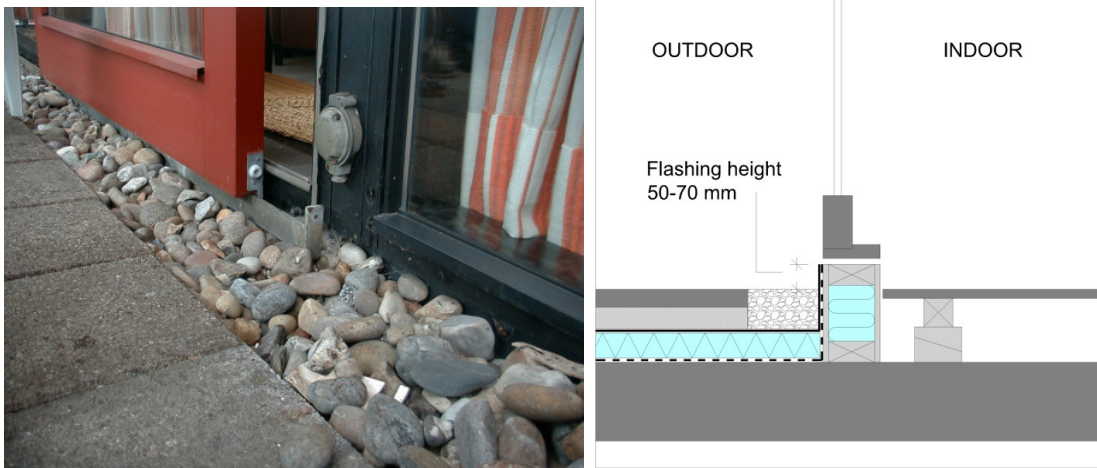
No changes were made to the flashings' height because it would involve changing the windows, doors and wooden facades between the apartments and terraces. Each terrace has two 6 m long façades facing the terrace, and the costs were considered to be too high, even taking into account that it was possible to obtain a 15-year warranty.

Figure 6: Example of flashings between terrace and apartment

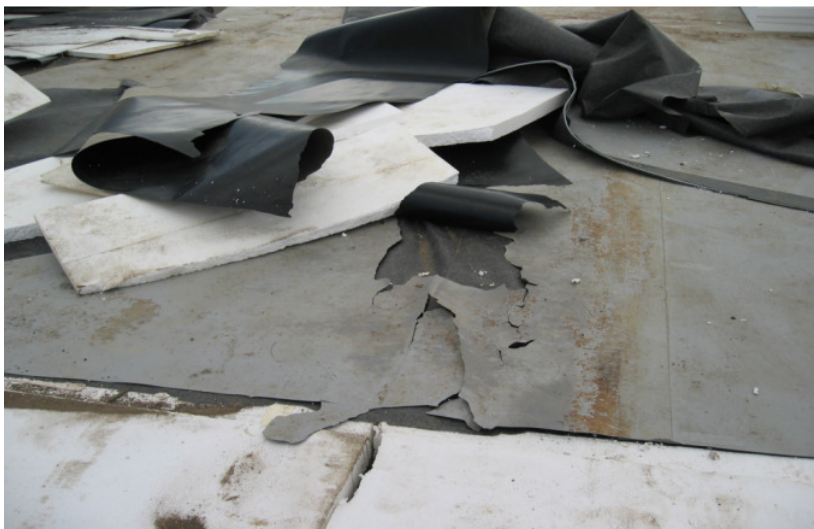
Figure 7: The loss of plasticizers was critical because it caused the membrane to shrink and become brittle.

The biological environment in the soil (bacteria and mold) on top of the membrane probably was the reason for the loss of plasticizers; the plasticizer content fell from 35 percent to 5 percent in 10-12 years. The loss of plasticizer to the EPS insulation was avoided by a separation layer of glass felt.

When the plasticizer content is below 20 percent, the product becomes brittle and cracks readily will occur if people walk on the roofs. The loss of plasticizers also causes the membrane to shrink, which leads to tension in the membrane and creates problems with the flashings, which are pulled off the underlayment.

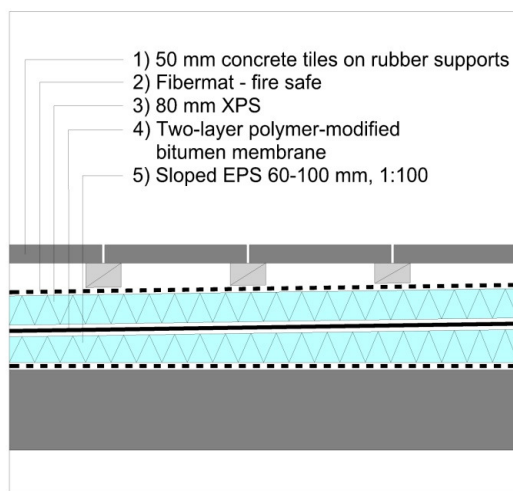
Furthermore, it was deemed important to ensure water readily could get away from the up stands and, therefore, the concrete pavers were placed on footings instead of in gravel as before. The roof's slope also was improved, and the design was changed to a duo roof system (partly inverted roof system) to keep the membrane frost-free during the winter. When using a partly inverted roof system design, the slope can be reduced to 1:100 instead of the normal (in Denmark) 1:40.

Figure 8: New roof construction of terraces after the second renovation. The roof membrane is protected between two layers of insulation, and water drainage is facilitated by using rubber supports for concrete pavers instead of gravel.

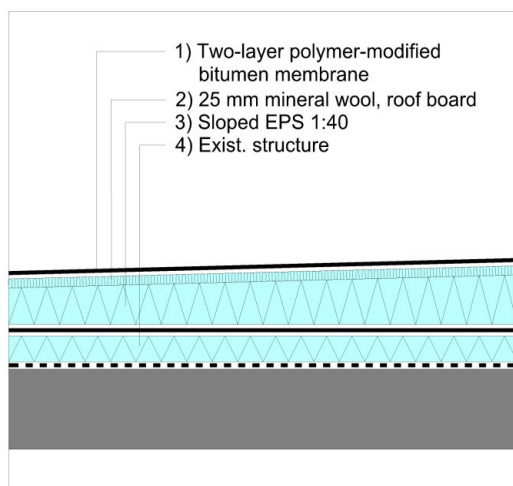
The slope was increased to 1:40 (25 mm/1 meter) using a tapered insulation corresponding to the standard for warm roof systems.

Figure 11: Warm roof system instead of vegetative or ballasted roof systems. The original roof membrane is maintained, the insulation and slope are improved, and the new roof membrane is fully visible.

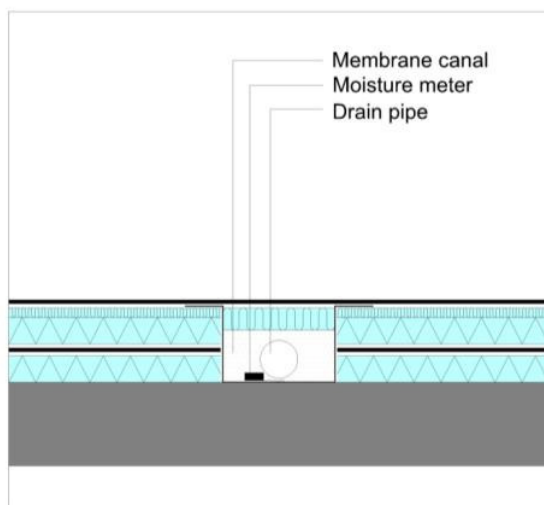
The distance between the outlets of the original roof systems were up to 20 meters apart, and new outlets had to be installed to avoid insulation that was too thick. It was not possible to install a new drainage system in the building, so drainage pipes were installed in the insulation to connect the new outlets to the old drainage system. A siphon system was used to make horizontal pipes possible.

This system often is used but is not considered to have the same safety as normal systems with visible pipes. Therefore, the pipes were installed in a special canal of polymer-modified bitumen roofing materials. The canal is equipped with moisture sensors, allowing it to be checked for water from leaks in the pipes. There are more than 350 moisture sensors installed, and each of them is checked once per year. After the first seven years, it has proved to be working because only five small leaks have been discovered.

Figure 12: Drainage pipe built into the insulation in a special canal made from the roof membrane

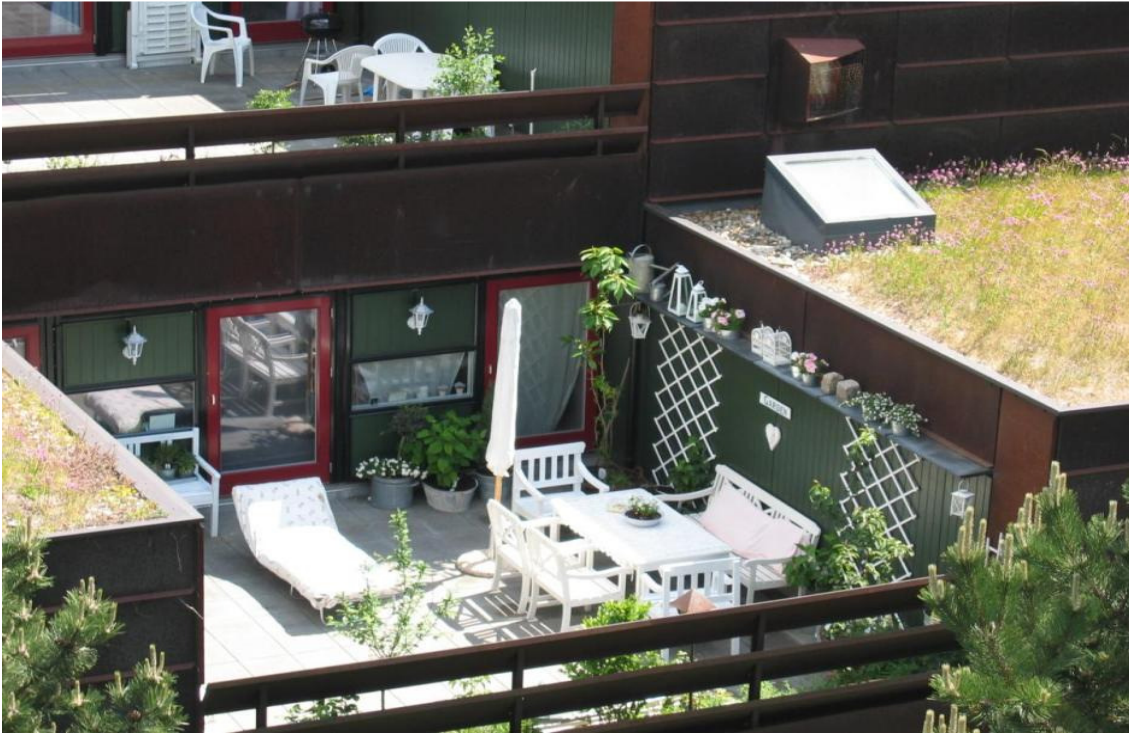
Figure 15: A cozy roof terrace without leaks

The design incorporates a warranty of 30 years, allowing a maximum of five of the 1,725 apartments to have leaks per year. If more leaks occur, no maintenance fee is paid for that year.

So far, only up to three leaks have occurred in one year, allowing the contractor his fee every year.
